**AIRBASE STRUCTURAL FACILITY
POSTATTACK RECOVERY - FOAL
EAGLE DEMONSTRATION**

**D.H. MERKLE, D.L. READ,
R.A. REID, J.M. UNDERWOOD,
N.F. KARASZEWSKI**

**APPLIED RESEARCH ASSOCIATES
P.O. BOX 40128
TYNDALL AFB FL 32403**

APRIL 1993

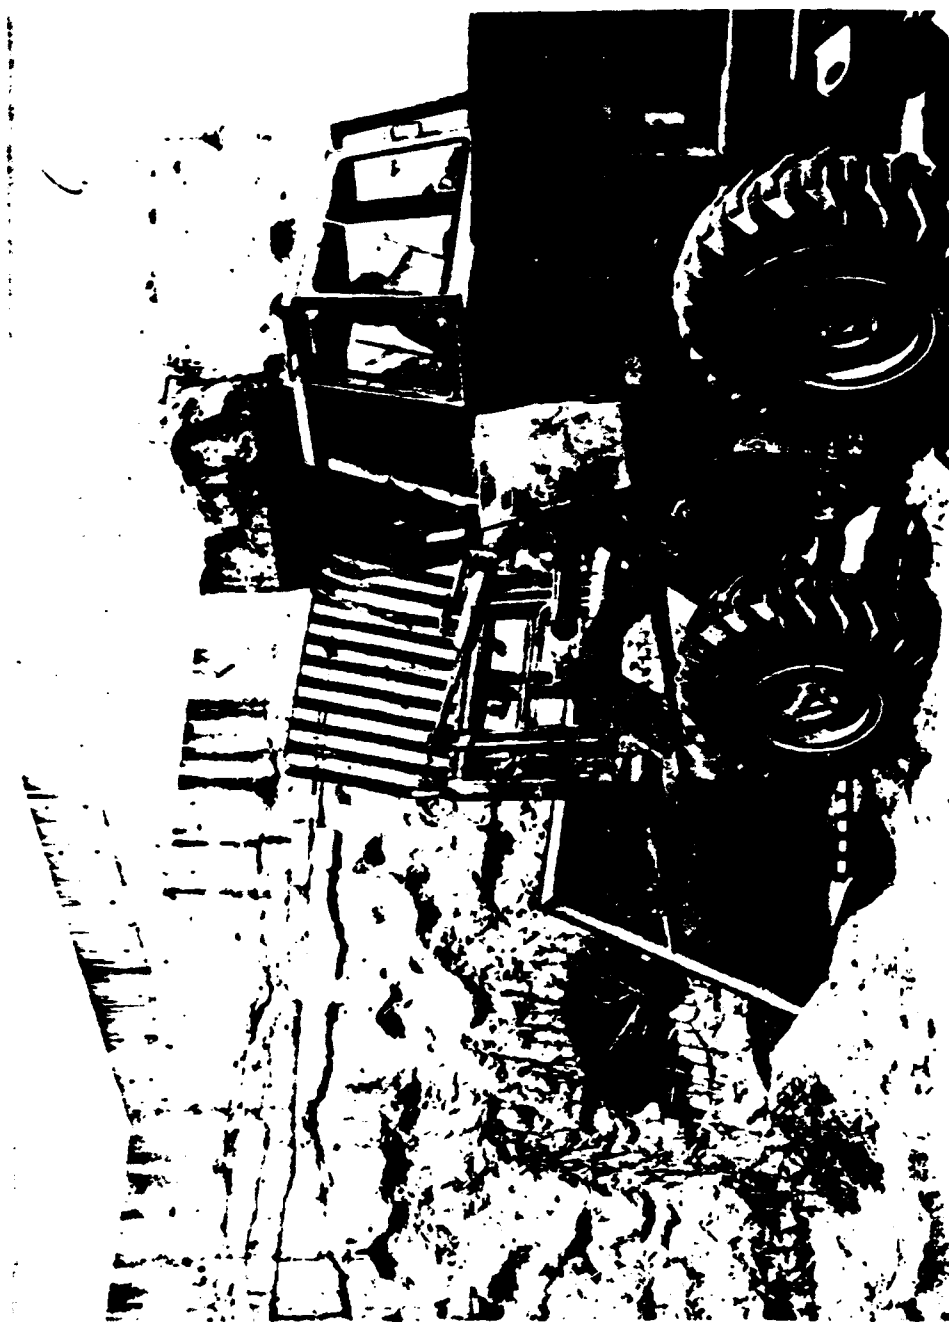
Two problems were encountered during the earth berm repair. The ramset stud gun used to secure the plywood backing behind the breach was old and worn out. Consequently, the charge cartridges stuck in the gun firing chamber after the charge had been fired. After each shot, it took several minutes to remove the spent cartridge before another could be inserted. Additionally, the stud gun often would not fire, even though its barrel was

Figure 11. Earth Berm Wall Replacement Repair In Progress.

firmly pressed against the plywood backing to disengage the safety mechanism. Another problem occurred during slab placement against the outside structure to cover the breach. It proved difficult and time-consuming to use the forks of the front-end loader to lean the slab against the structure to cover the breach. It was difficult to center the slab over the breach and obtain the correct lean angle.

The second problem was the unsatisfactory performance of the old, worn out ramset stud gun used to secure plywood backing behind the earth berm and shotcrete wall breach repairs. To overcome this problem, a new stud gun was purchased.

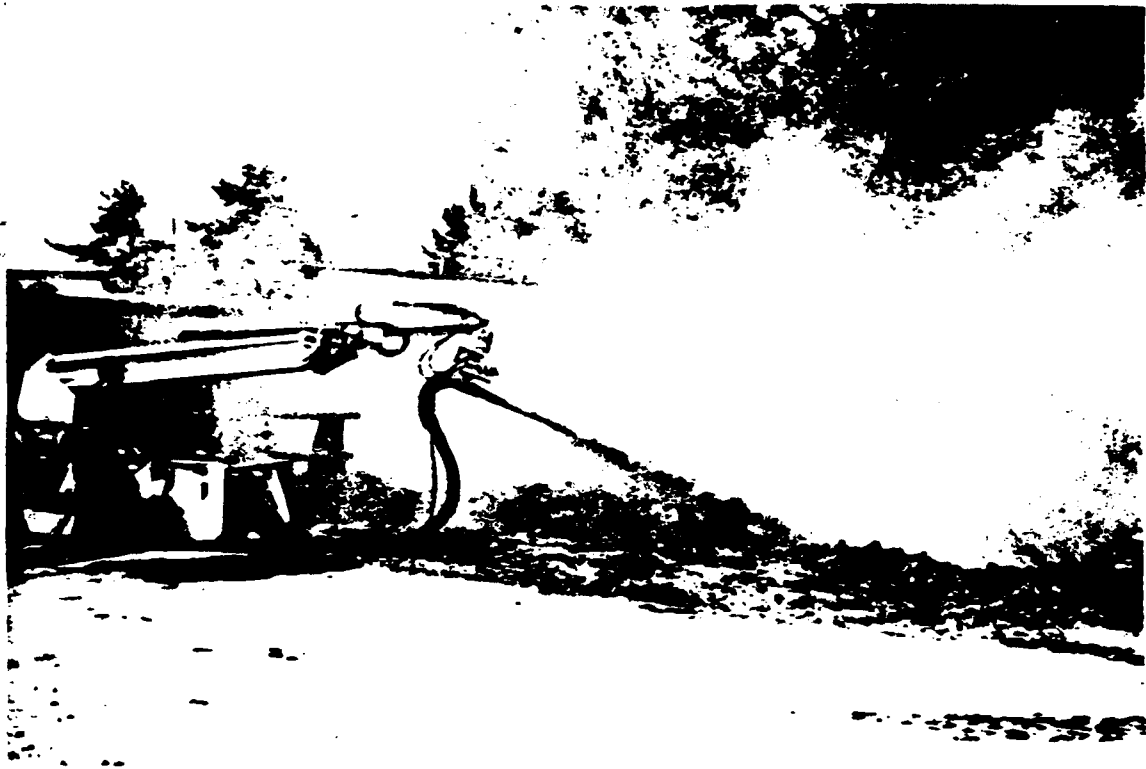
Two significant problems were encountered while lining the ditch. The first involved control of the water flow rate to the shotcrete nozzle, which in turn controlled the water content of the shotcrete material. If the water flow rate is too high, the shotcrete material becomes too wet and sloughs off instead of building up on the repair surface. If the water flow rate is too low, the material is too dry and will not stick to the repair surface. It took approximately 30 minutes to troubleshoot the water supply system and obtain the correct flow rate in a reliable manner.

Figure 18. Lining Drainage Ditch With Shotcrete.

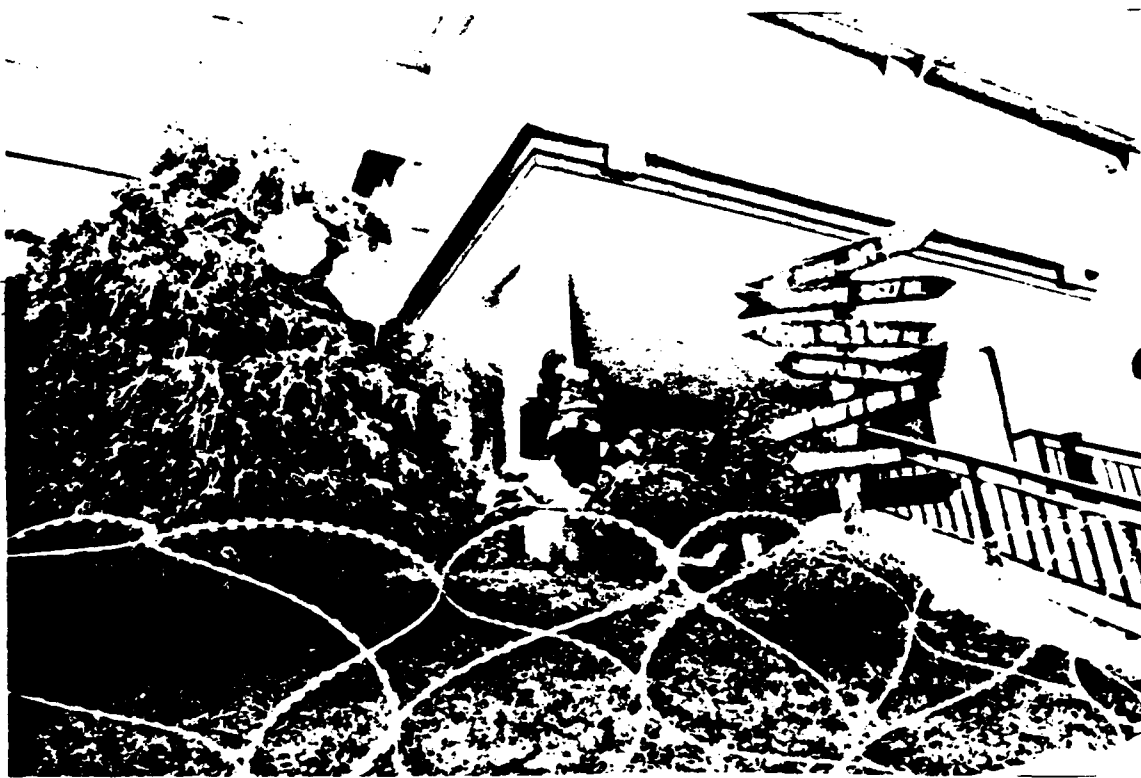
Figure 25. Completed Column Splint Repair At 7AF Headquarters During The FOAL EAGLE Exercise.

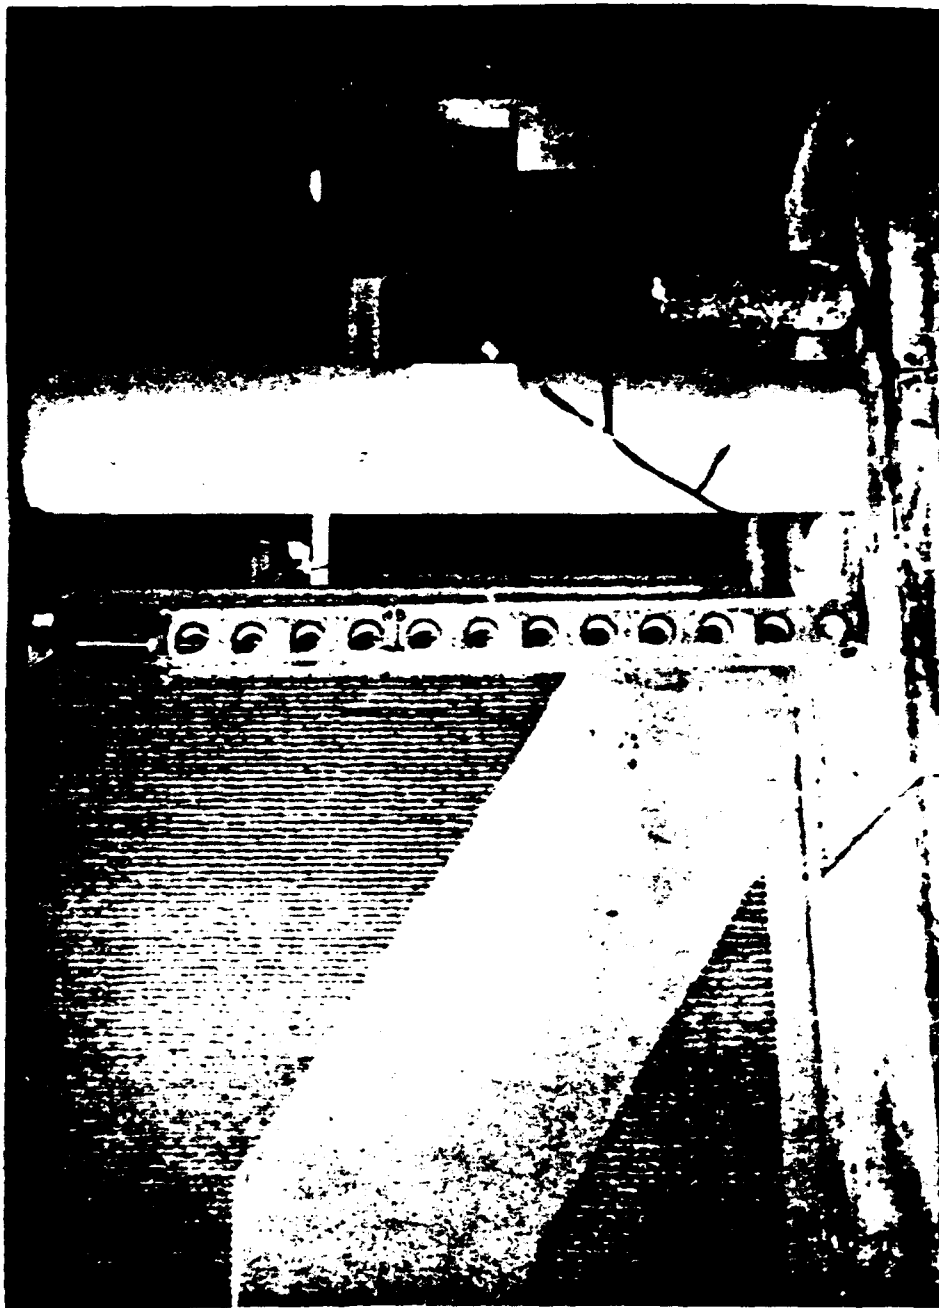
The column replacement demonstration went well. No significant problem was encountered during the process. The completed column shoring repair is shown in Figure 26.

Figure 26. Completed Column Replacement Repair During The
FOAL EAGLE Exercise.
